## THE RELOCATION OF A HERITAGE BRIDGE

Author: ing P. Hogesteeger<sup>1</sup>

<sup>1</sup>Royal HaskoningDHV, Department Transport & Planning, Rotterdam, The Netherlands

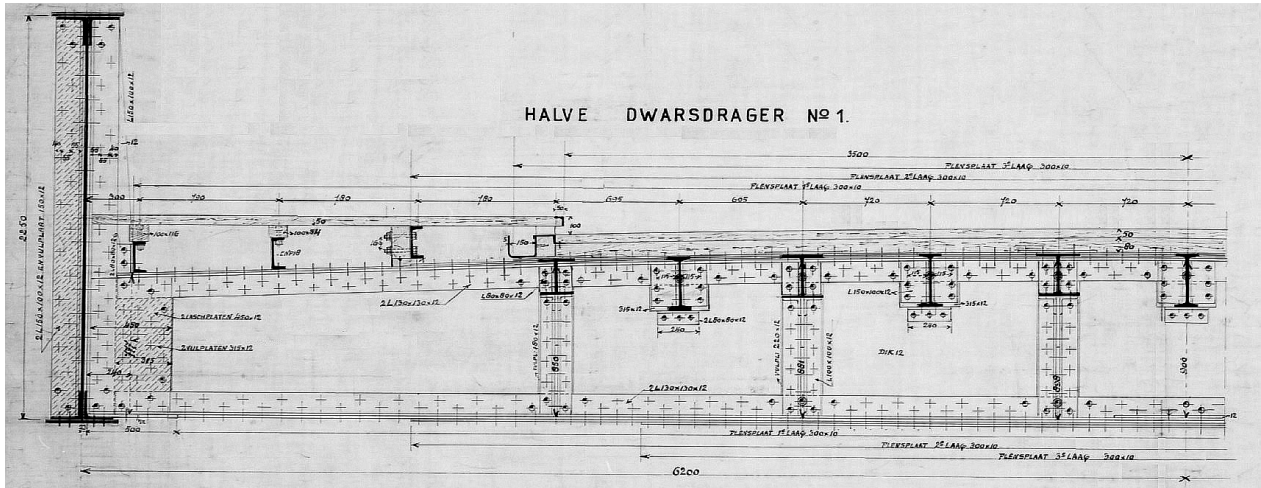
Fig. 4. Fraction of an original drawing of the cross girders with H=900mm.

Only the lower secondary girder (H=900 mm) did not meet the requirements for stability under the load of two lorries of 60T and 40T in opposite directions at the same moment over this girder. It was advised to prohibit the use of the bridge by any two heavy weight lorries at the same time. For other traffic categories two-way traffic will be allowed.

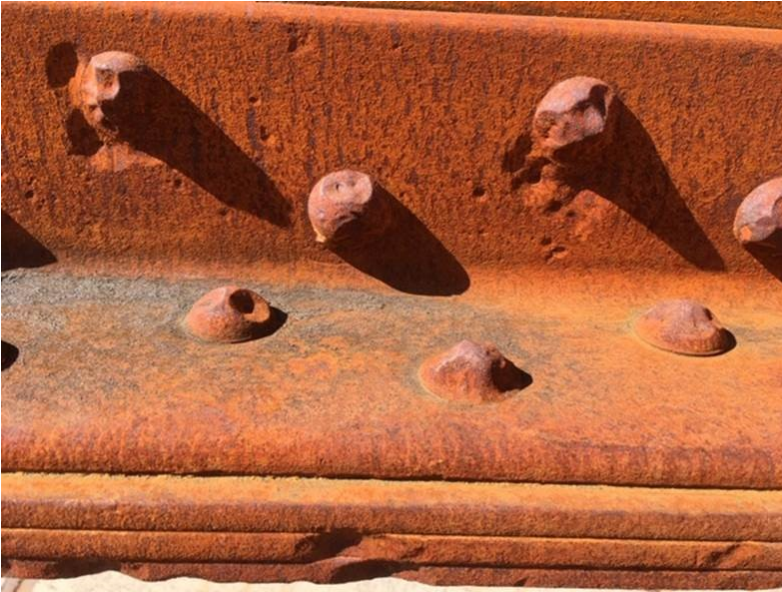
From the start it was clear that the wooden planking of the deck and its direct supporting steel beams were not salvageable. The deck had rotted away in several locations, the steel beams were heavily corroded.

*Fig. 7. Corroded rivets in bottom flange.*

As part of the re built of this bridge many rivets will be replaced by pre-tensioned injection bolts. Also (too heavily) corroded parts of the girders will be exchanged with new steel plates. Fig. 7
